Sister Judy Martinez  
Working in Neighborhoods, Inc.  
3726 Llewellyn Avenue  
Cincinnati, Ohio 45223

PRELIMINARY ASSESSMENT  
HERRON AVENUE PROJECT  
CINCINNATI, OHIO  
ATC PROJECT NO. 72.24907.0001

July 2, 2003

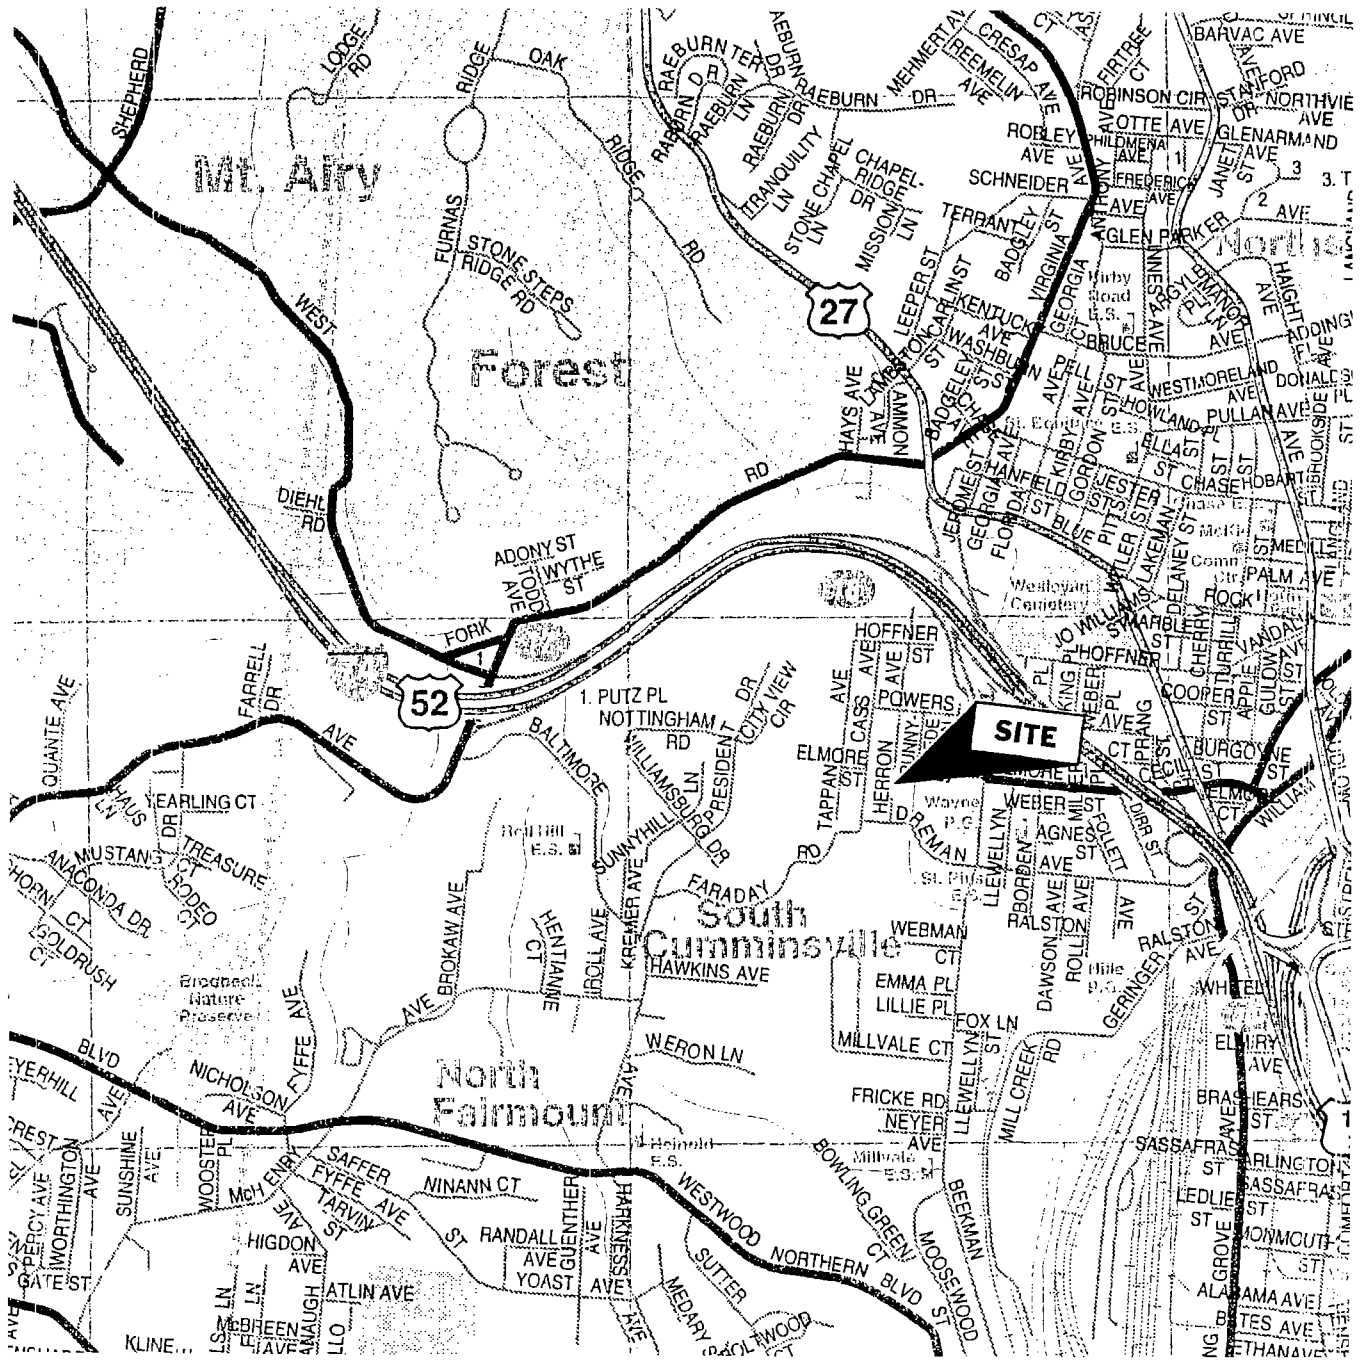
### Figure 1

ATC Associates Inc. (ATC) completed a Preliminary Assessment of the Herron Avenue Project located in Cincinnati, Ohio, during March - May 2003. The Study Area is shown on Figure 1 and a Site Location Map is presented as Figure 2. The study was conducted on behalf of Working in Neighborhoods, Inc. (WIN), in general accordance with ATC Proposal No. EM-029-04, dated March 25, 2003. This report documents our findings.

It should be noted that as shown on Figures 1 and 2 and as presented in Appendix F of the Mundell report, geophysical data was not collected in the following areas due to vegetation and irregular terrain associated with current construction activities: along the east side of the site area located to the east of the City of Cincinnati R-O-W and west of the area of drum exposure indicated on the west bank of the creek, and in two sections located in the northwest portion of the site.

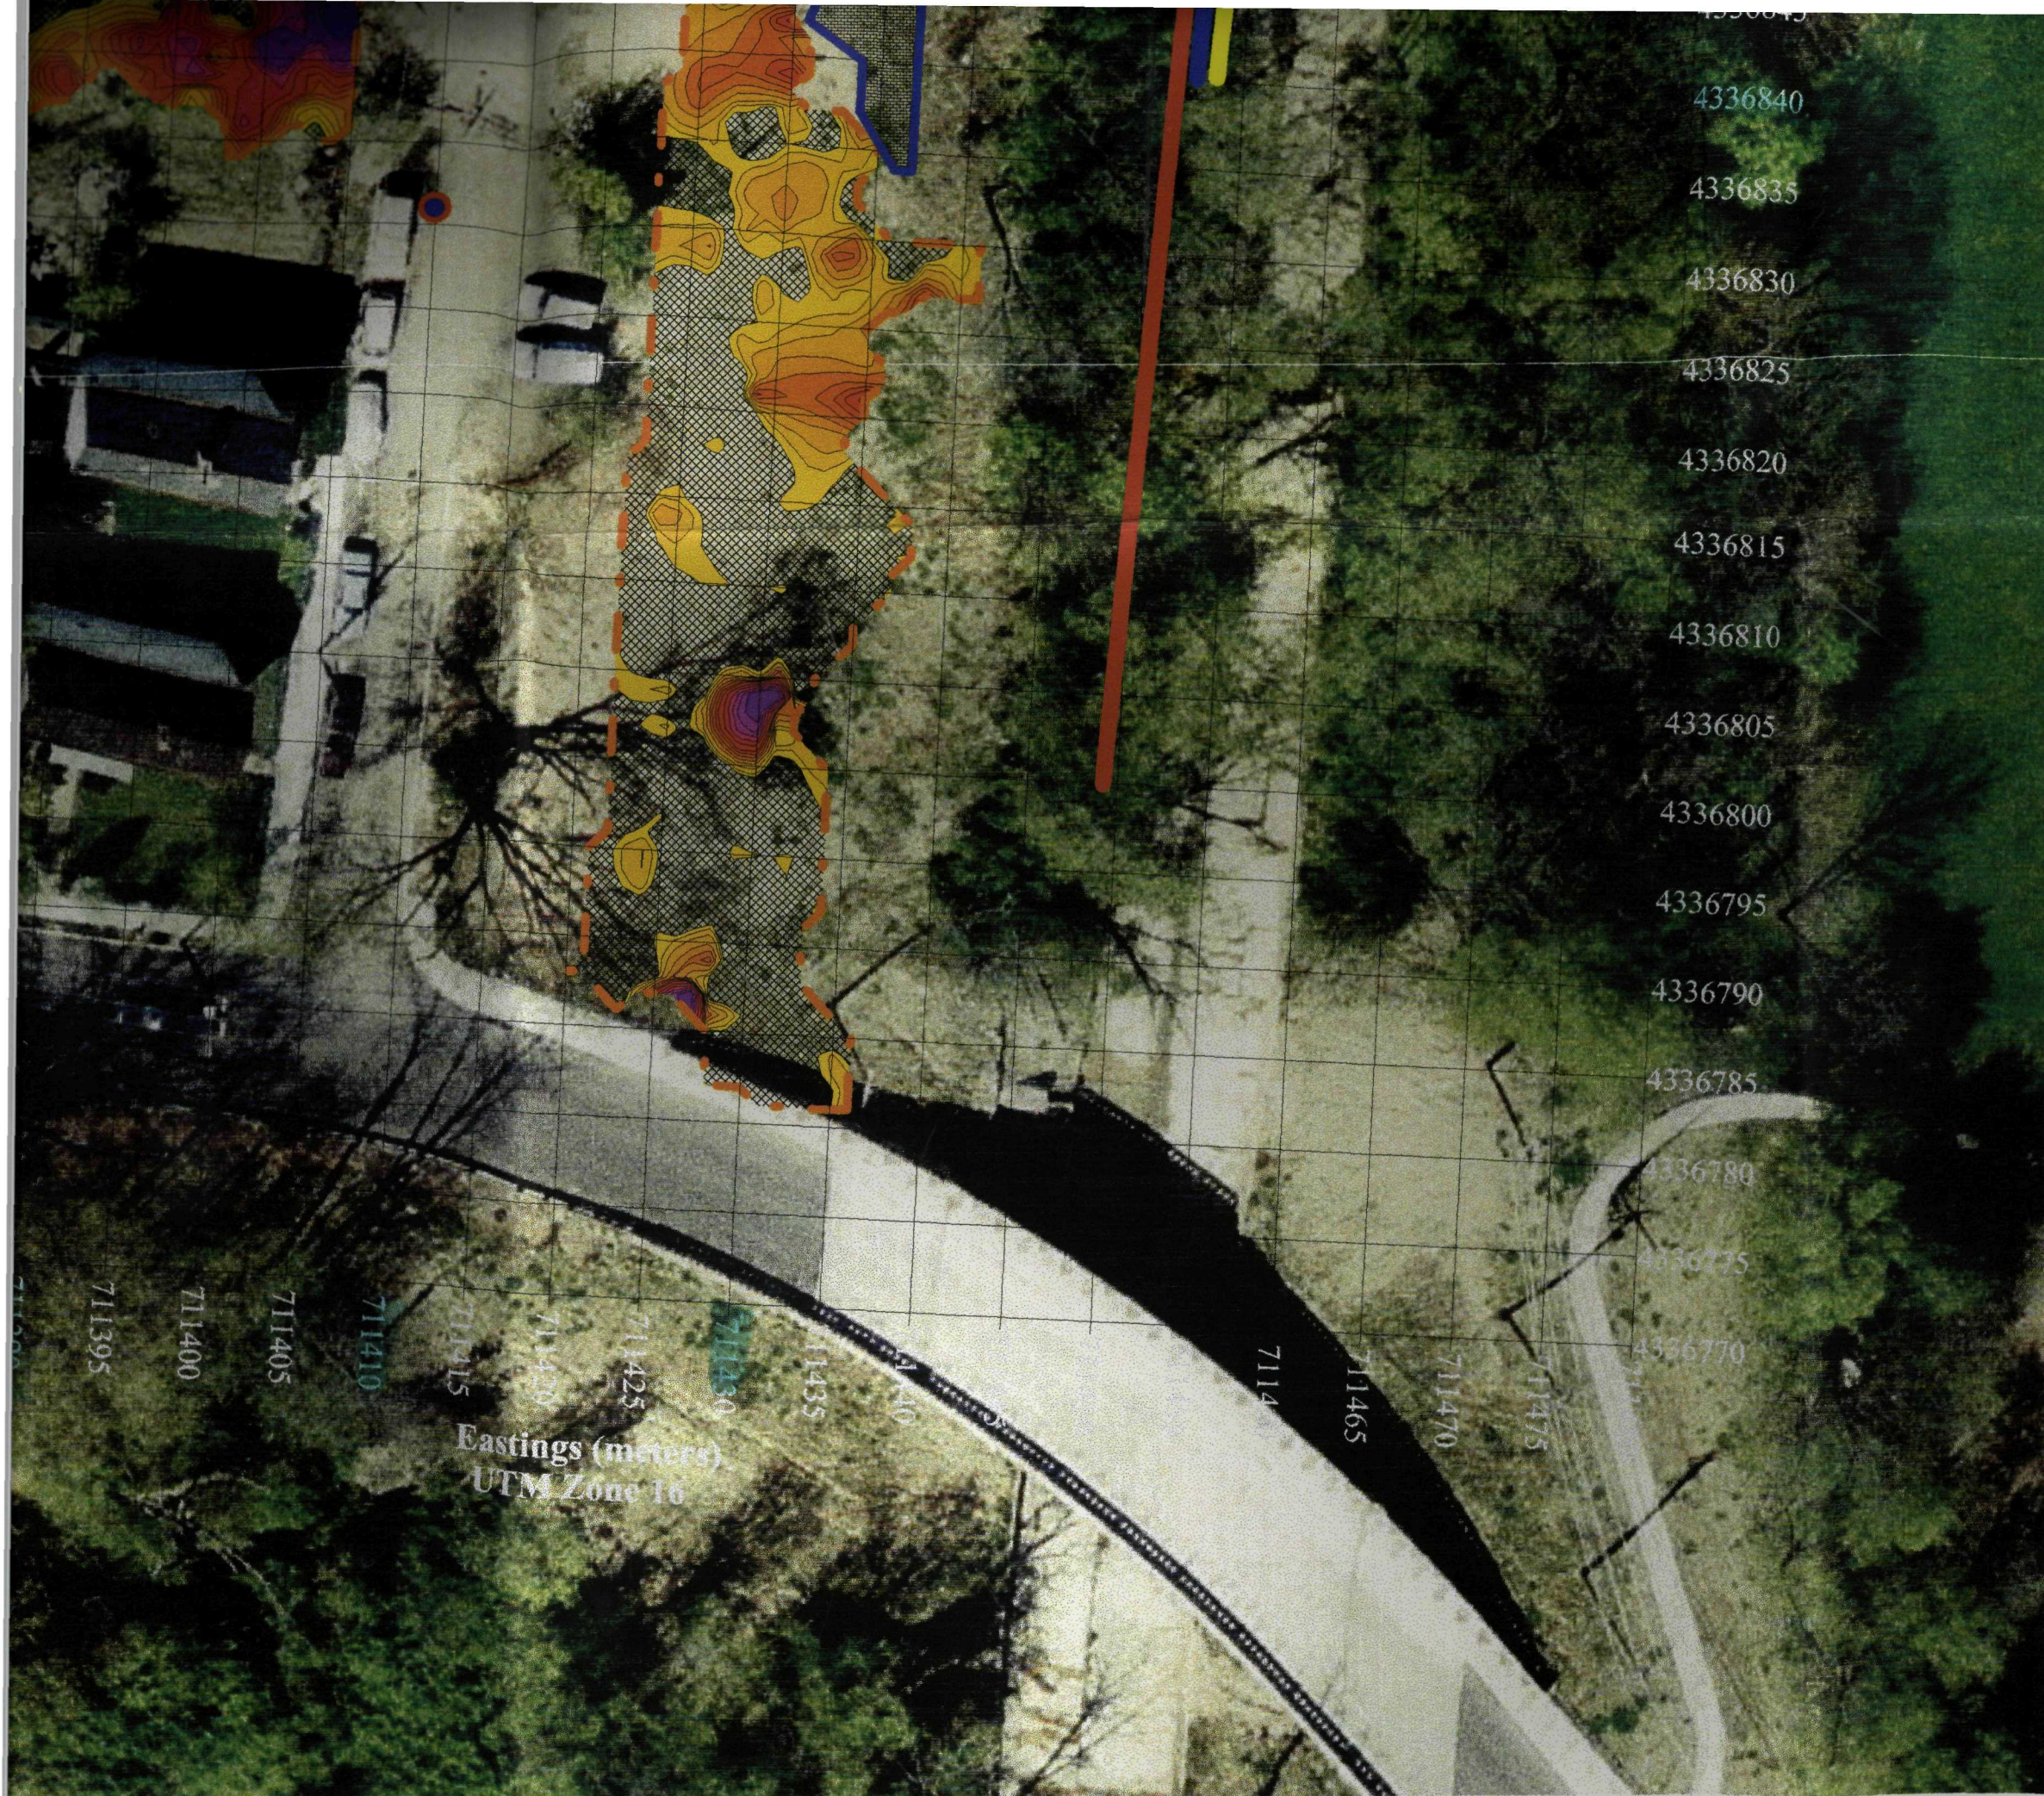
Attachments: Figure 1. EM-61 Channel Three Map  
Figure 2. EM-61 Channel Difference Map

A large number of relatively strong anomalies caused by buried metallic objects are found on the Channel Difference map (Figure 2), mostly in the northern two-thirds of the Site<sup>1</sup>. Based upon MUNDELL'S prior experience with metal detection surveys where drum burial was documented, significant accumulations of buried metal generally have a channel

<sup>1</sup> The red to violet areas observed on the Channel Three map (Figure 1) are primarily interpreted as being caused by debris, scrap metal, old castings, etc., that were observed at the surface during the data collection process.

EM-61 metal detection mapping has revealed occurrences of numerous sporadically placed metallic objects with corresponding anomalies that vary widely in size and shape. These metallic objects were placed in accumulations of domestic and industrial wastes in a somewhat haphazard pattern. The central portion of the Site contains a laterally extensive collection of surficial metallic objects which strongly influenced the EM-61 survey. The deeper-focused Channel Difference data indicates a number of locations of buried metallic objects found within the Site. The nature of the metallic objects at these locations is not known at this time; however, most of the anomalies are not consistent with examples of systematic drum burial (i.e., organized burial in regularly shaped excavations) with which MUNDELL has had prior experience. However, the largest anomaly, centered at UTM 711402E, 4336935N, likely represents a significant accumulation of buried metal, and has a somewhat organized appearance possibly consistent with systematic drum burial.

If greater certainty regarding the origin of the geophysical anomalies is desired, it is recommended that direct observation (excavation) be conducted, particularly at the exceptional anomaly noted above. Each area of potential interest can be located by the UTM coordinates given on Figures 1 and 2, or by direct measurement from Site features portrayed on the aerial photo base map.
